SINGLE FAMILY HOME

Inspection Date: 9/13/2022

123 mystery st

Collins Property Inspection and Services LLC

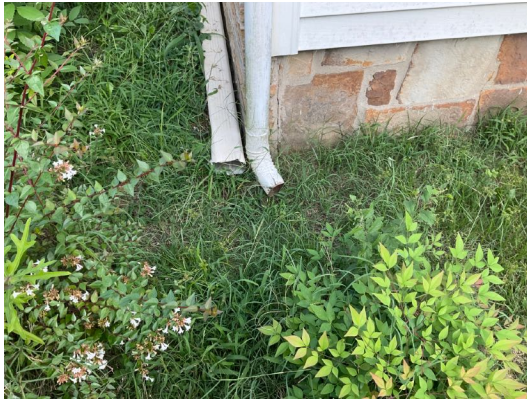
Location: Front Side

Comments: Downspouts empty at the base of the foundation wall this can lead to settlement issues. The addition of downspout extensions is recommended to divert water away from the foundation

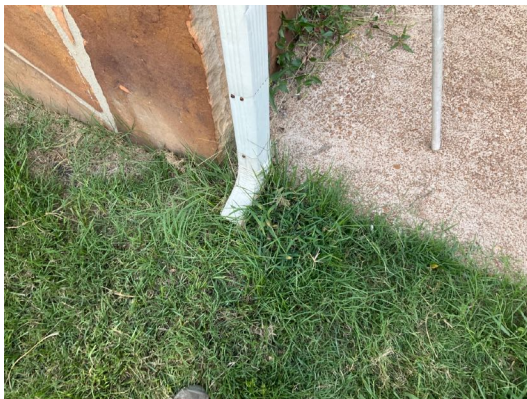
Location: Rear Side

Comments: : Downspouts empty at the base of the foundation wall this can lead to settlement issues. The addition of downspout extensions is recommended to divert water away from the foundation

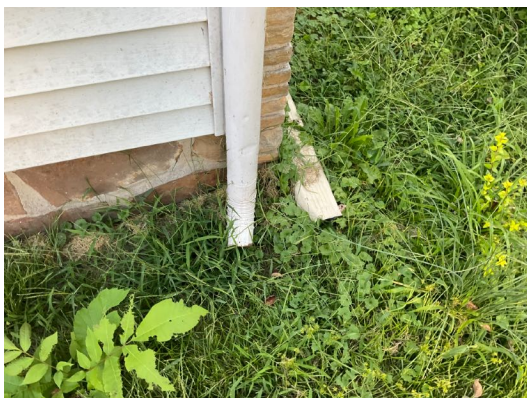
Comments: Downspouts empty at the base of the foundation wall this can lead to settlement issues. The addition of downspout extensions is recommended to divert water away from the foundation

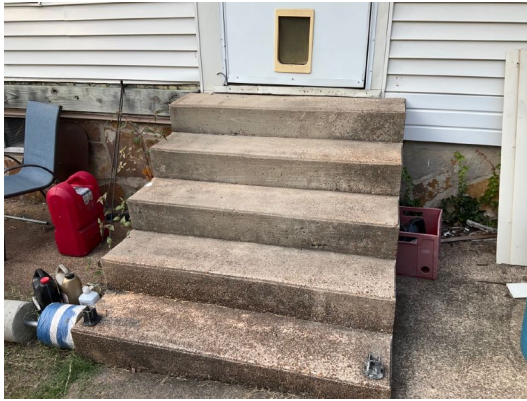
Comments: The stairs do not have adequate handrails. Handrails should be graspable to prevent falling and injury. Correction is recommended to prevent injury.

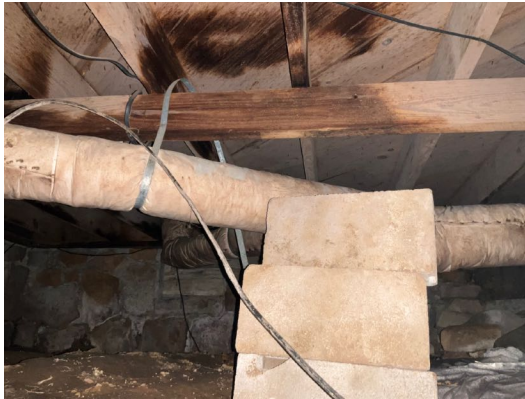
Comments: The piers in the crawlspace are actively failing. This may be due to settlement of soils and or lack of adequate storm water management. Further evaluation by a licensed structural engineer is recommended.

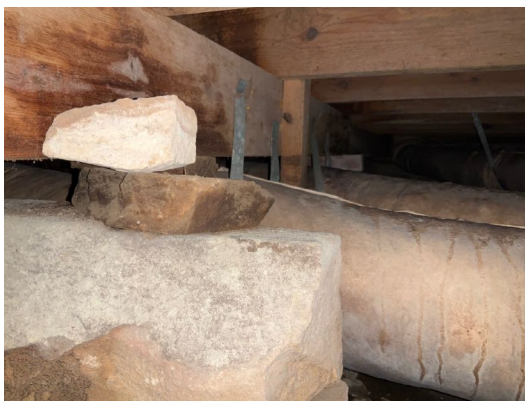
Comments: A combination of brick and natural stone has been used to wedge between the bottoms of the floor joist and the foundation piers. This does not allow for the joist to bear evenly on top of the pier and could lead to sagging floor joist or possible failure of the joist or other structural members.

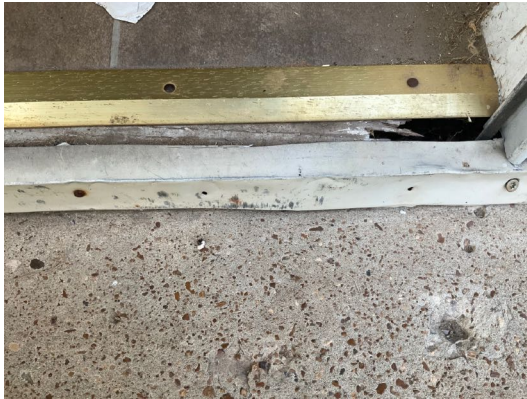
Comments: Deterioration at rear entry door framing recommend replacement by qualified carpenter

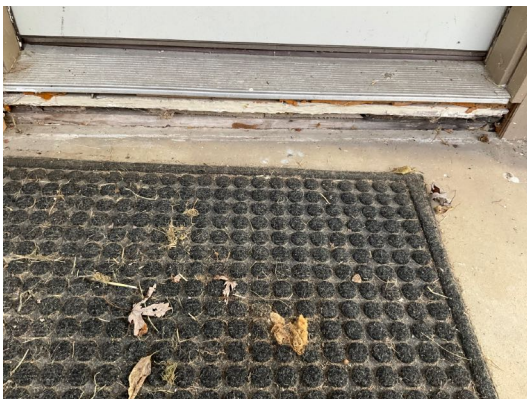
Comments: Trim missing from front door framing. Recommend replacement by qualified carpenter

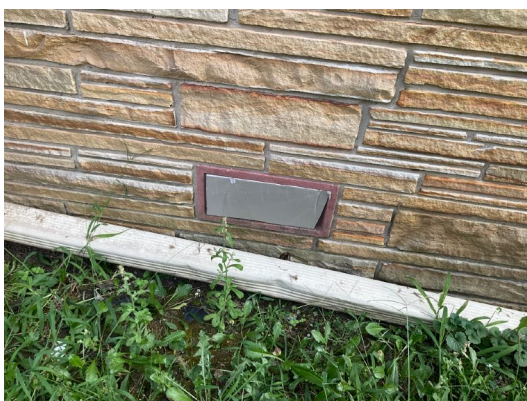
Comments: The crawl space vents have been plugged. With out the proper amount of crawlspace ventilation issues with moisture intrusion can occur including mold, wood destroying organisms, settlement issues, etc. Recommend removing the plugs immediately.

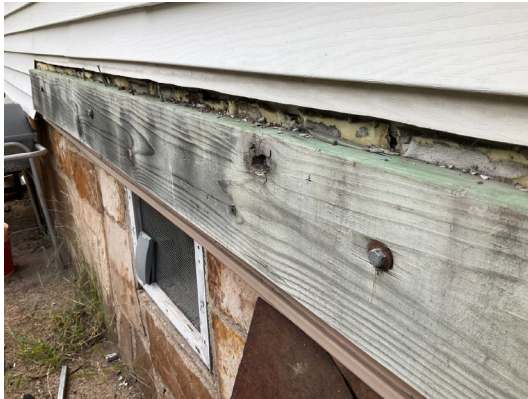
Comments: A Ledger board from a deck that has been removed is still present on the back side of the house. This ledger board is not properly flashed and is open along the top edge allowing for possible moisture intrusion. Recommend remediation by a qualified carpenter.

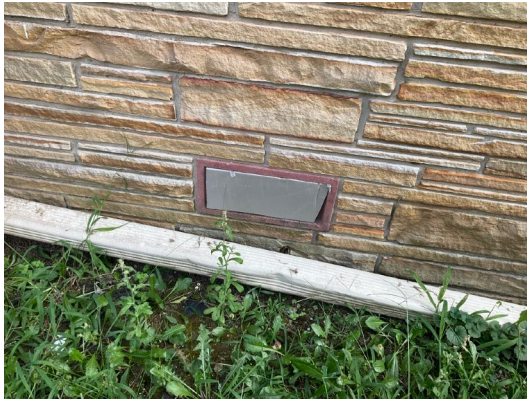
Comments: The crawl space vents have been plugged. With out the proper amount of crawlspace ventilation issues with moisture intrusion can occur including mold, wood destroying organisms, settlement issues, etc. Recommend removing the plugs immediately.

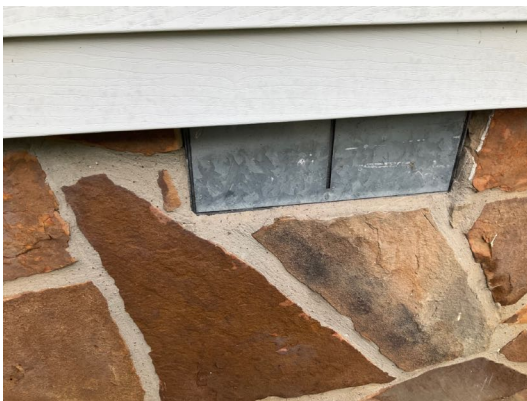
Comments: The crawl space vents have been plugged. With out the proper amount of crawlspace ventilation issues with moisture intrusion can occur including mold, wood destroying organisms, settlement issues, etc. Recommend removing the plugs immediately.

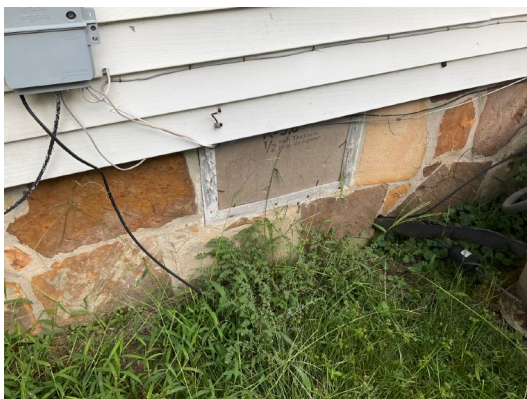
Comments: The crawl space vents have been plugged. With out the proper amount of crawlspace ventilation issues with moisture intrusion can occur including mold, wood destroying organisms, settlement issues, etc. Recommend removing the plugs immediately.

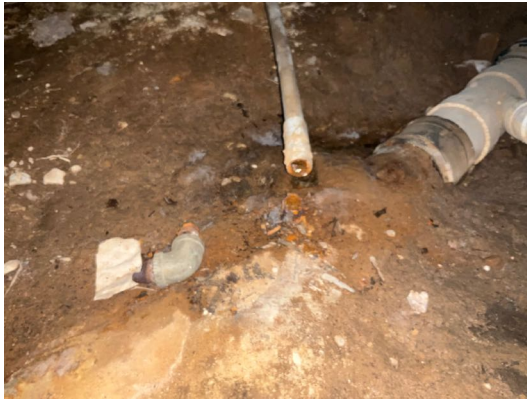
Comments: The air conditioning condensate drain line is discharging directly into the crawlspace this can cause issues with moisture intrusion, recommend remediation by a qualified plumber.

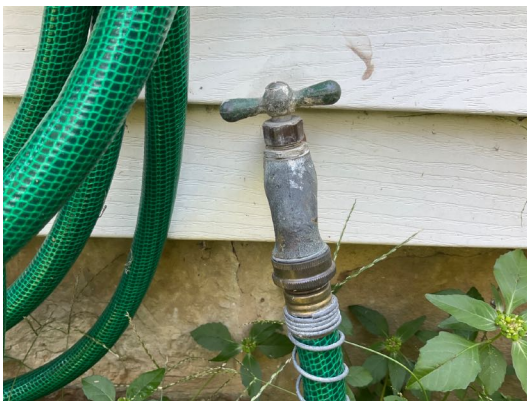
Comments: The hose spigot lacks backflow prevention. A backflow preventer is recommended to prevent back siphonage or back pressured water contaminating the utility water supply. Installation of a rated backflow preventer is recommended.

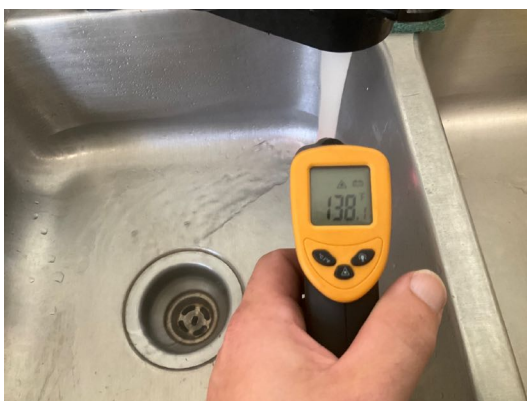
Comments: The hot water supply temperature is above 120 F which is considered a scalding hazard. Adjustment of the hot water temperature at the water heater is recommended to be no more than 120 F at a fixture.

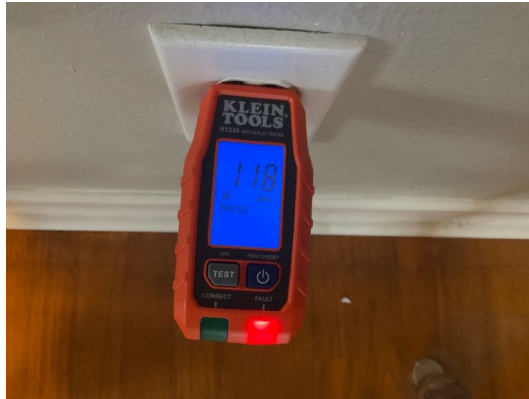
Comments: The receptacle outlet was tested to have an open ground or no ground. Grounds direct voltage surges and protect against electrocution. Further evaluation is recommended.

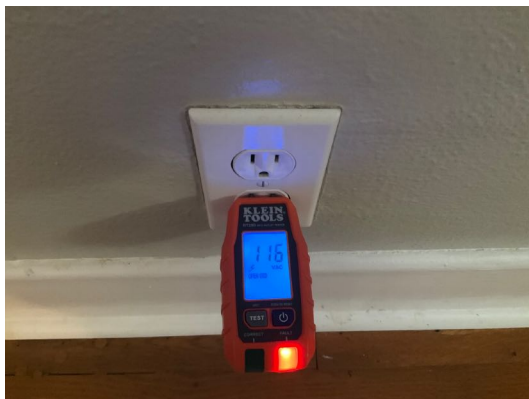
Comments: The receptacle outlet was tested to have an open ground or no ground. Grounds direct voltage surges and protect against electrocution. Further evaluation is recommended.

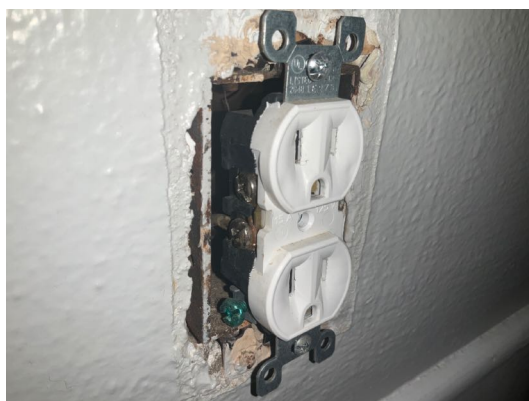
Comments: Three prong grounded receptacles have been installed on a 2 wire ungrounded system ;this condition is found in may locations throughout the home. recommend further evaluation by a qualified electrician.

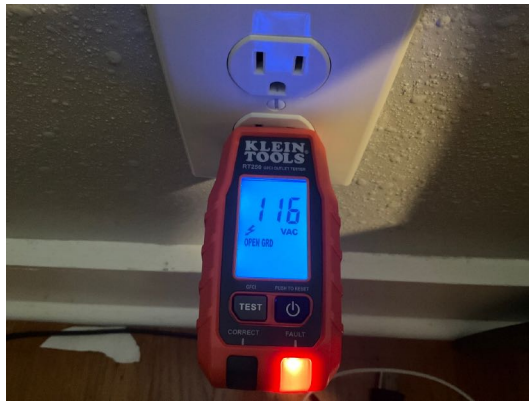
Comments: The receptacle outlet was tested to have an open ground or no ground. Grounds direct voltage surges and protect against electrocution. Further evaluation is recommended.

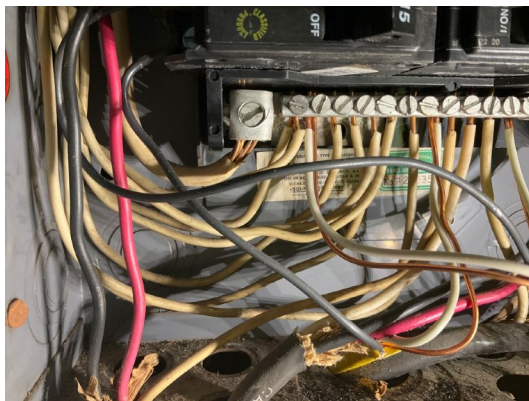
Comments: Double taps or double lugging was noted. This is more than one conductor under one contact point. This can create loose connections creating an arc potential leading to a fire or possibly overloading the circuit leading to a fire. Correction is recommended.

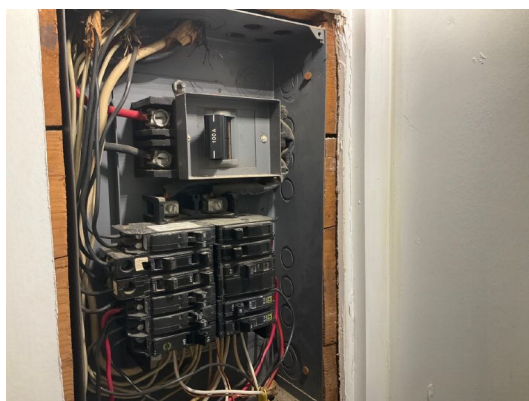
Comments: The electrical system lacked adequate grounding. Grounding gives a path of least resistance for stray current and an alternate path for returning current. This creates both an electrocution and fire hazard. Adequate grounding is recommended.

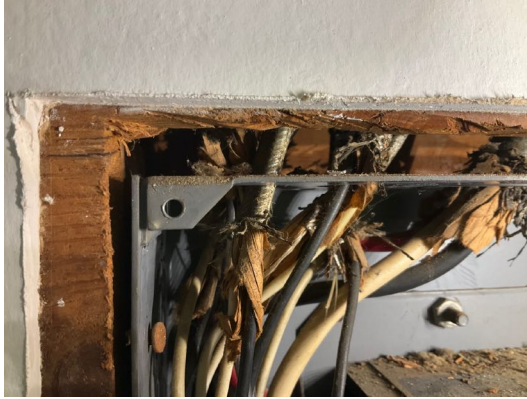
Comments: The electrical system is comprised of predominantly cloth shielded or “rag wrap” wiring; this wiring is of very advanced age. Also, this style of wiring system lacks a ground conductor. Without a proper grounding system there is a significant increase in the risk for electrocution or damage to modern electronic equipment that relies on grounding protection. Recommend further evaluation by a qualified electrician.

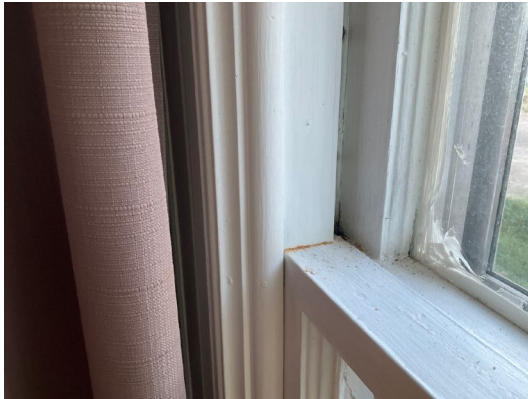
Comments: The windows in the living room have been nailed shut and are not openable, thus preventing the use of the window as an emergency escape route; this represents a significant safety hazard. Recommend further evaluation by a window contractor.

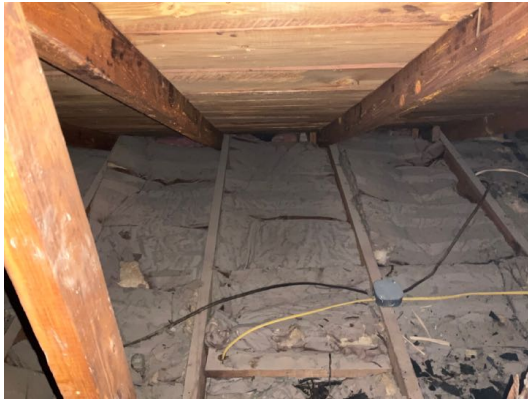
Location: Various Locations

Comments: The attic lacks adequate insulation. Insulation increases efficiency of the home, prevents ice damming in cold climates, and condensation issues. It is recommended to add insulation.

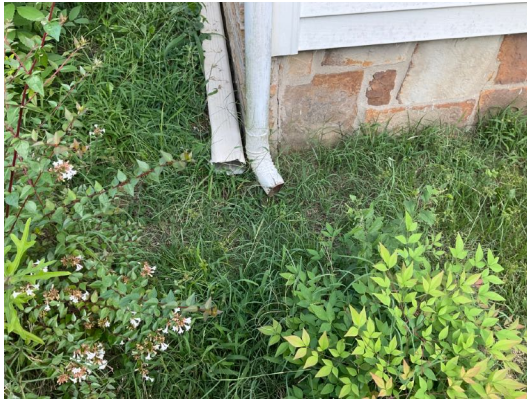
Comments: Downspouts empty at the base of the foundation wall this can lead to settlement issues. The addition of downspout extensions is recommended to divert water away from the foundation

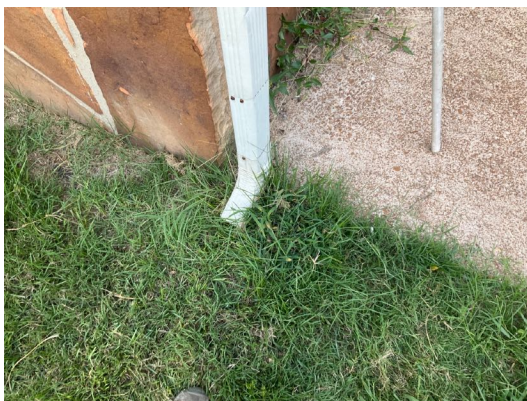
Comments: : Downspouts empty at the base of the foundation wall this can lead to settlement issues. The addition of downspout extensions is recommended to divert water away from the foundation

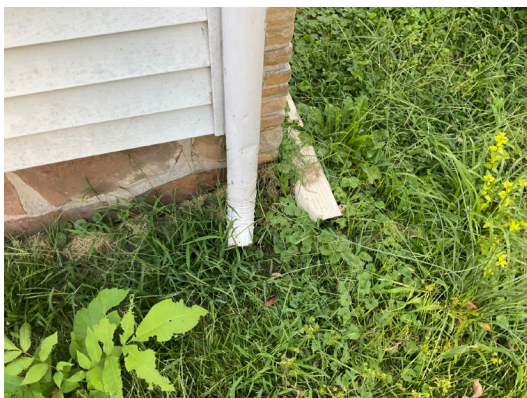
Comments: Downspouts empty at the base of the foundation wall this can lead to settlement issues. The addition of downspout extensions is recommended to divert water away from the foundation

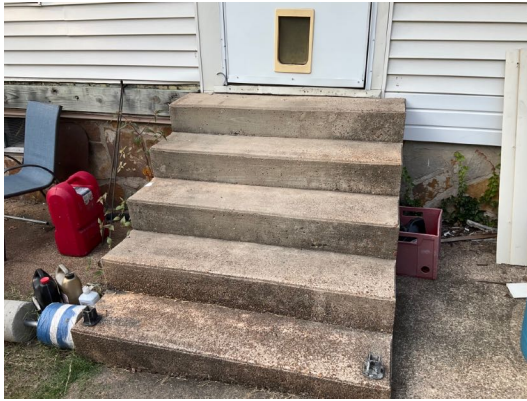
Comments: The stairs do not have adequate handrails. Handrails should be graspable to prevent falling and injury. Correction is recommended to prevent injury.

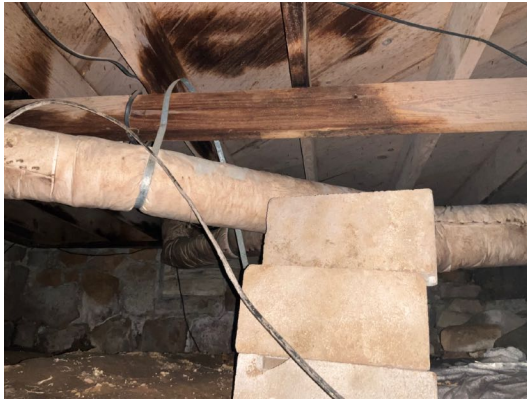
Comments: The piers in the crawlspace are actively failing. This may be due to settlement of soils and or lack of adequate storm water management. Further evaluation by a licensed structural engineer is recommended.

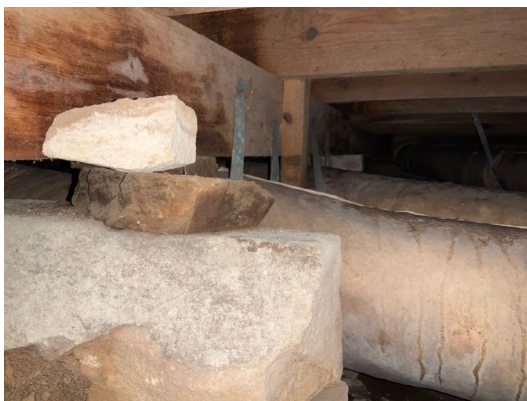
Comments: A combination of brick and natural stone has been used to wedge between the bottoms of the floor joist and the foundation piers. This does not allow for the joist to bear evenly on top of the pier and could lead to sagging floor joist or possible failure of the joist or other structural members.

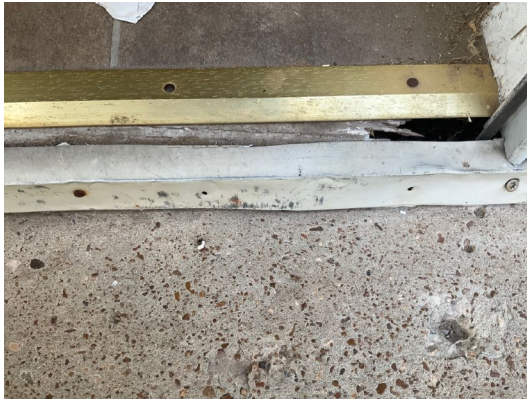
Comments: Deterioration at rear entry door framing recommend replacement by qualified carpenter

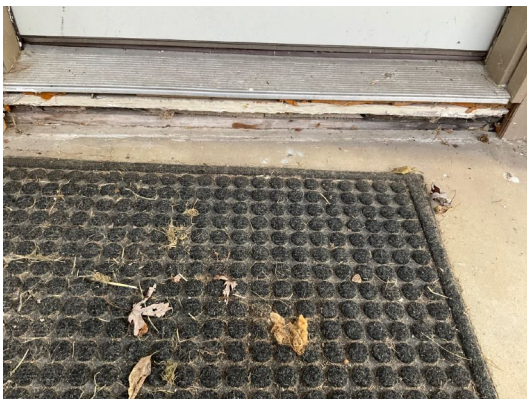
Comments: Trim missing from front door framing. Recommend replacement by qualified carpenter

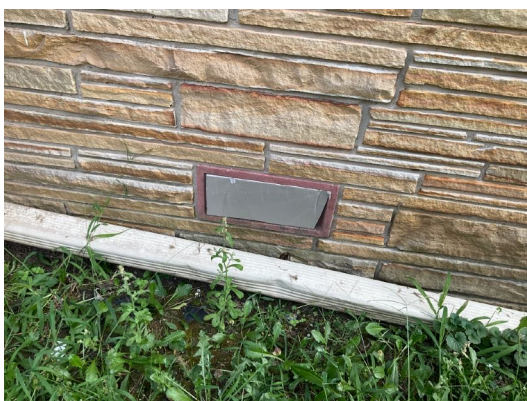
Comments: The crawl space vents have been plugged. With out the proper amount of crawlspace ventilation issues with moisture intrusion can occur including mold, wood destroying organisms, settlement issues, etc. Recommend removing the plugs immediately.

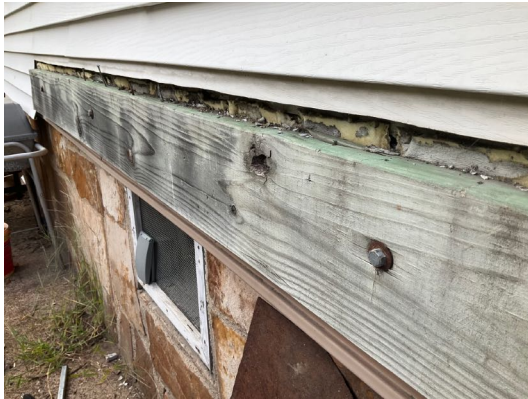
Comments: A Ledger board from a deck that has been removed is still present on the back side of the house. This ledger board is not properly flashed and is open along the top edge allowing for possible moisture intrusion. Recommend remediation by a qualified carpenter.

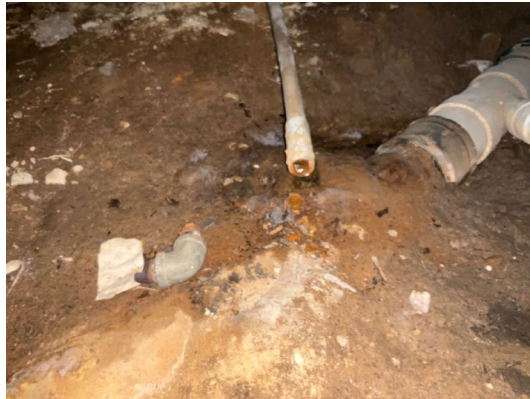
Comments: The air conditioning condensate drain line is discharging directly into the crawlspace this can cause issues with moisture intrusion, recommend remediation by a qualified plumber.

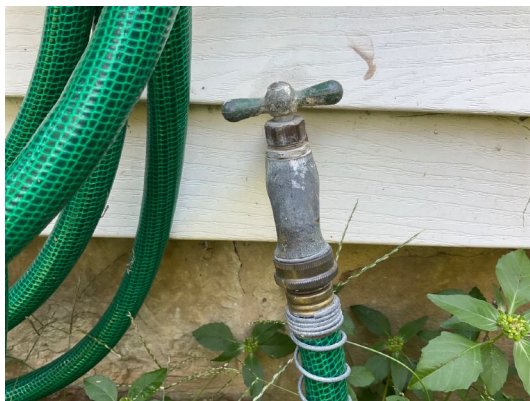
Comments: The hose spigot lacks backflow prevention. A backflow preventer is recommended to prevent back siphonage or back pressured water contaminating the utility water supply. Installation of a rated backflow preventer is recommended.

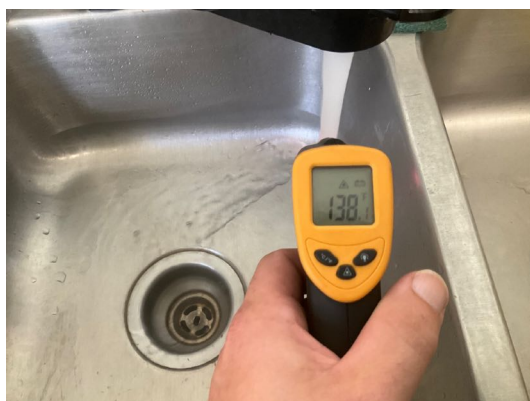
Comments: The hot water supply temperature is above 120 F which is considered a scalding hazard. Adjustment of the hot water temperature at the water heater is recommended to be no more than 120 F at a fixture.

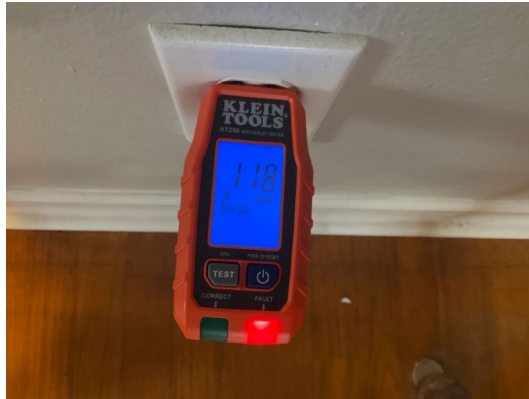
Comments: The receptacle outlet was tested to have an open ground or no ground. Grounds direct voltage surges and protect against electrocution. Further evaluation is recommended.

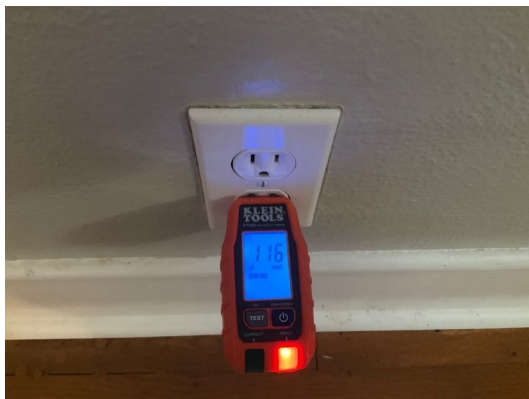
Comments: The receptacle outlet was tested to have an open ground or no ground. Grounds direct voltage surges and protect against electrocution. Further evaluation is recommended.

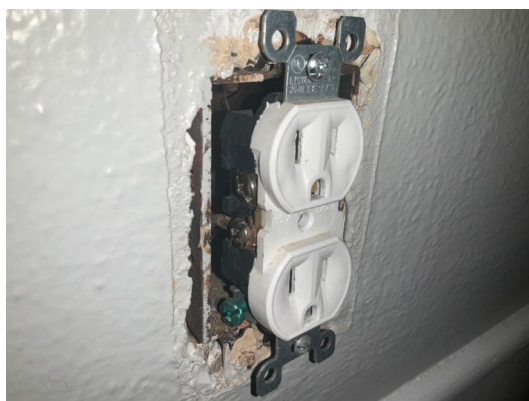
Comments: Three prong grounded receptacles have been installed on a 2 wire ungrounded system ;this condition is found in may locations throughout the home. recommend further evaluation by a qualified electrician.

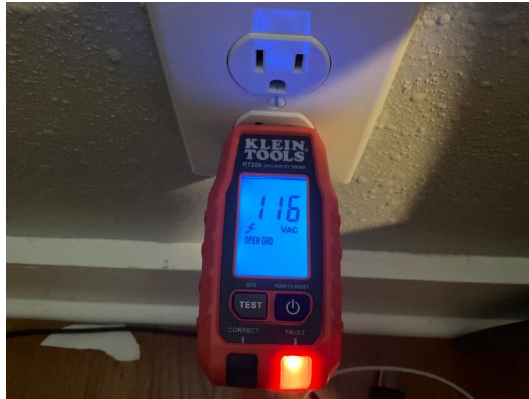
Comments: The receptacle outlet was tested to have an open ground or no ground. Grounds direct voltage surges and protect against electrocution. Further evaluation is recommended.

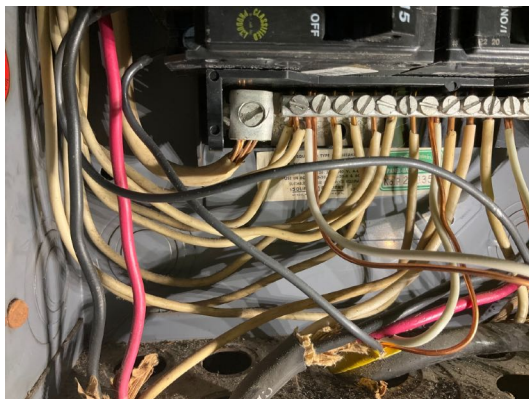
Comments: Double taps or double lugging was noted. This is more than one conductor under one contact point. This can create loose connections creating an arc potential leading to a fire or possibly overloading the circuit leading to a fire. Correction is recommended.

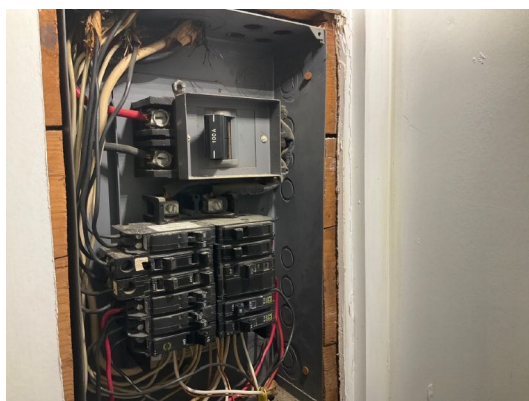
Comments: The electrical system lacked adequate grounding. Grounding gives a path of least resistance for stray current and an alternate path for returning current. This creates both an electrocution and fire hazard. Adequate grounding is recommended.

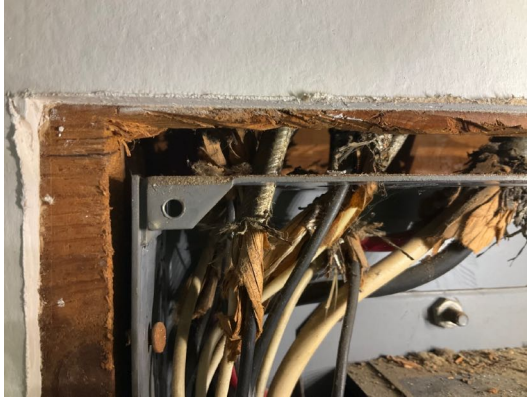
Comments: The electrical system is comprised of predominantly cloth shielded or “rag wrap” wiring; this wiring is of very advanced age. Also, this style of wiring system lacks a ground conductor. Without a proper grounding system there is a significant increase in the risk for electrocution or damage to modern electronic equipment that relies on grounding protection. Recommend further evaluation by a qualified electrician.

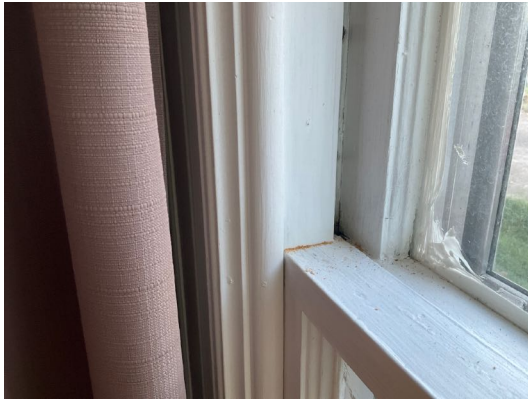
Comments: The windows in the living room have been nailed shut and are not openable, thus preventing the use of the window as an emergency escape route; this represents a significant safety hazard. Recommend further evaluation by a window contractor.

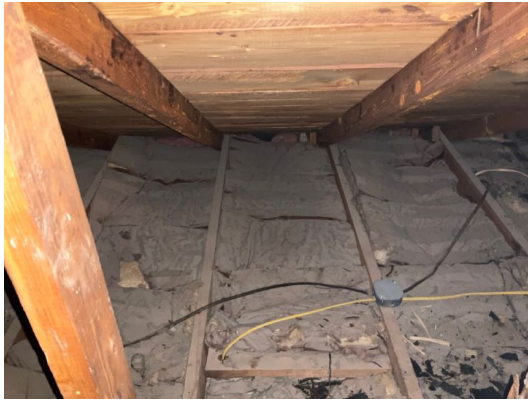
Location: Various Locations

Comments: The attic lacks adequate insulation. Insulation increases efficiency of the home, prevents ice damming in cold climates, and condensation issues. It is recommended to add insulation.

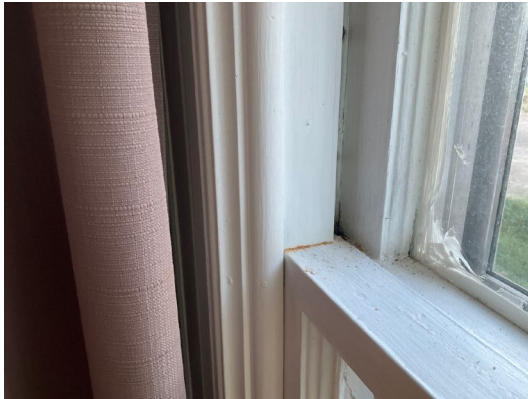
Comments: The windows in the living room have been nailed shut and are not openable, thus preventing the use of the window as an emergency escape route; this represents a significant safety hazard. Recommend further evaluation by a window contractor.
