SINGLE FAMILY HOME

Inspection Date: 9/13/2022

123 mystery st

Collins Property Inspection and Services LLC

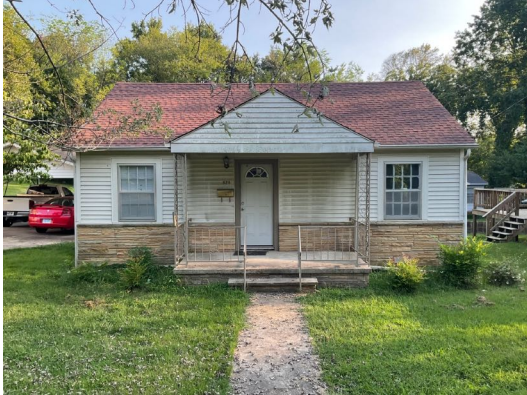
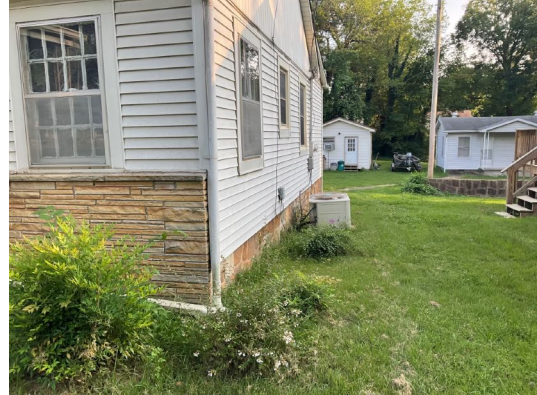
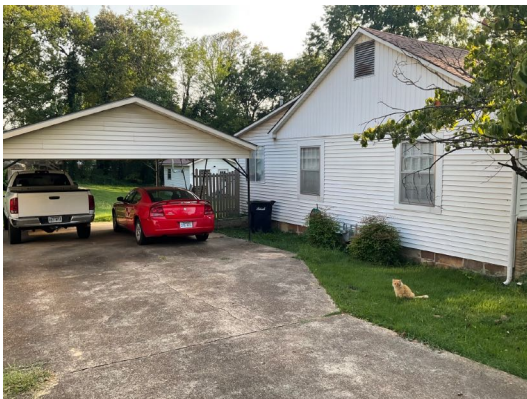
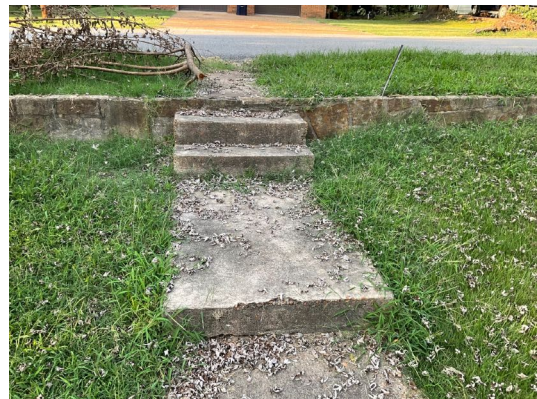
Comments: Downspouts empty at the base of the foundation wall this can lead to settlement issues. The addition of downspout extensions is recommended to divert water away from the foundation

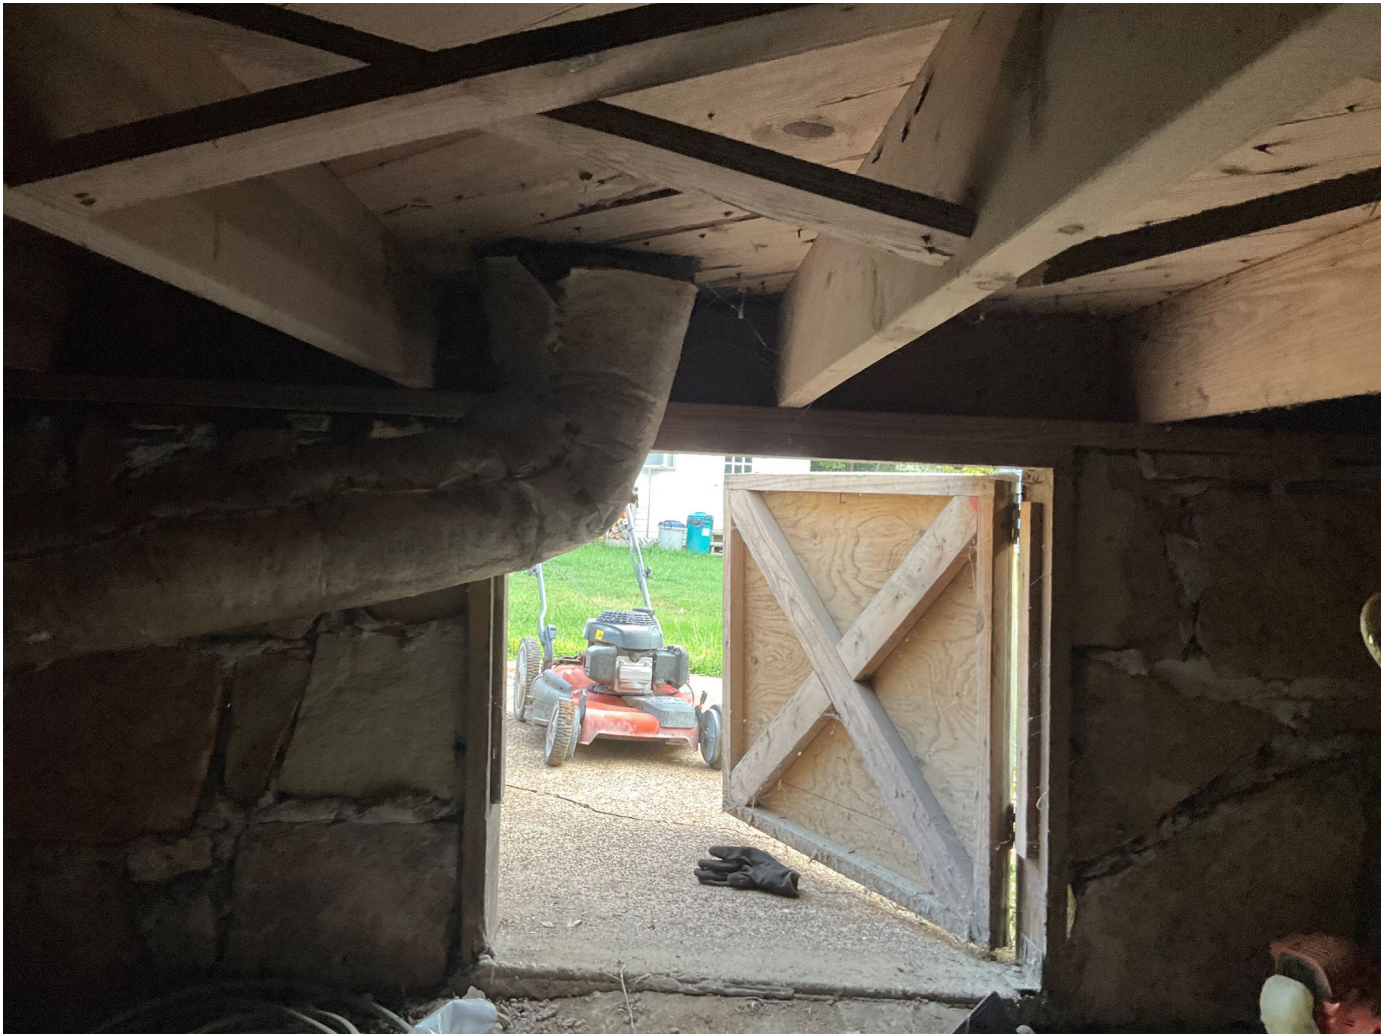
Structural

Comments: The piers in the crawlspace are actively failing. This may be due to settlement of soils and or lack of adequate storm water management. Further evaluation by a licensed structural engineer is recommended.

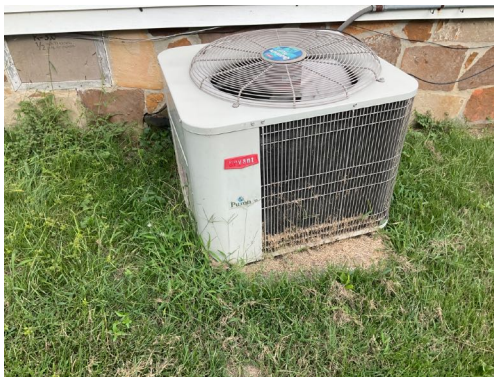
Condenser/Compressor

Equipment Operation: Operational, but nearing the end of its expected lifespan.

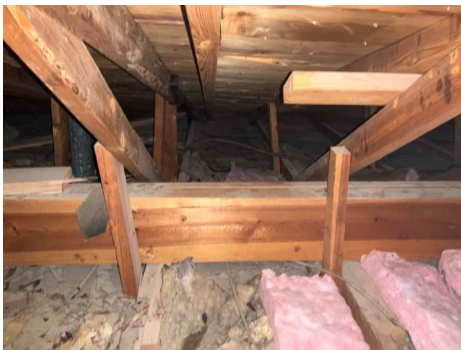
Comments: The attic lacks adequate insulation. Insulation increases efficiency of the home, prevents ice damming in cold climates, and condensation issues. It is recommended to add insulation.

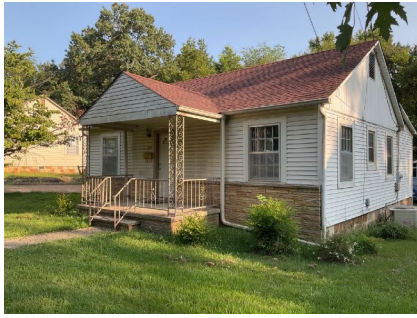
Location: Living Room 1

Comments: The windows in the living room have been nailed shut and are not openable, thus preventing the use of the window as an emergency escape route; this represents a significant safety hazard. Recommend further evaluation by a window contractor.

Level of Remediation: Window contractor
